Regency "Swinging" Bridge

By James Taylor
Goldthwaite Eagle

The Regency Suspension Bridge (1939) across the Colorado River is one of the most handsome surviving bridges in Texas. It is a fine representative example of the type of suspension spans erected for rural use throughout the United States in the years between the two world wars.

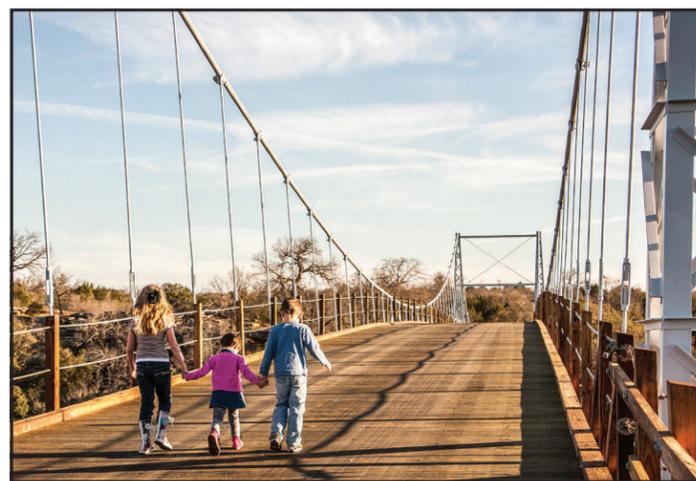
Regency "Swinging" Bridge, one of the last suspension bridges in service, is a favorite local attraction

The bridge consists of a 340-foot suspension span which is added to a 54-foot girder approach span at its north end. The foundations and piers are concrete, and the four towers consist of welded angle steel topped with cast-steel saddles to support the cables. The cables comprise 475 individual strands of no. 9 galvanized wire with a combined diameter of 3.25 inches. The 16-foot long roadway consists of wooden timbers supported on steel floor beams.

The initial work on the Regency Bridge centered on excavating anchors for the steel chambers. As this work progressed, foundations were dug for the abutments and piers, concrete was poured for these portions of the structure. Four welded-steel towers with saddle casting in their tops were erected over the piers. Then cables were strung to support a light wooden catwalk stretching 340 feet across the river valley between the towers.
