Regency “Swinging” Bridge

By James Taylor
Goldthwaite Eagle

HISTORY

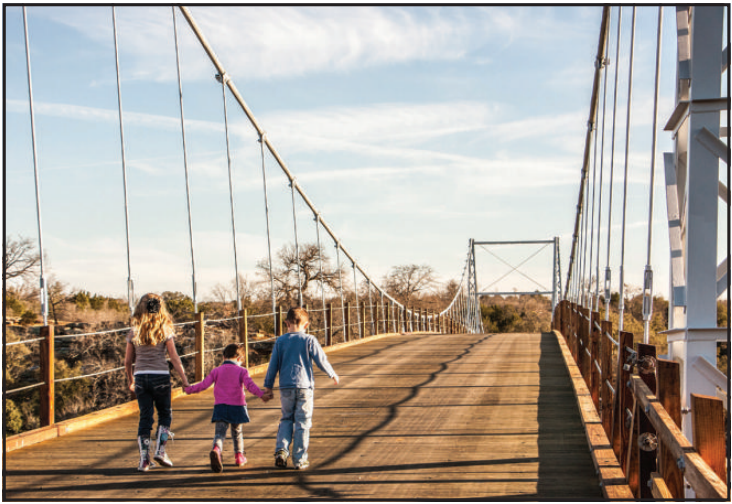
Regency “Swinging” Bridge, one of the last suspension bridges in service, is a favorite local attraction

The bridge consists of a 340-foot suspension span which is added to a 54-foot girder approach span at its north end. The foundations and piers are concrete, and the four towers consist of welded angle steel topped with cast-steel saddles to support the cables. The cables comprise 475 individual strands of no. 9 galvanized wire with a combined diameter of 3.25 inches. The 16-foot long roadway consists of wooden timbers supported on steel floor beams.
