# Local attractions bridge past and present

Parker and Swartz covered bridges are just two local Wyandot County attractions that bridge the area's past and present.

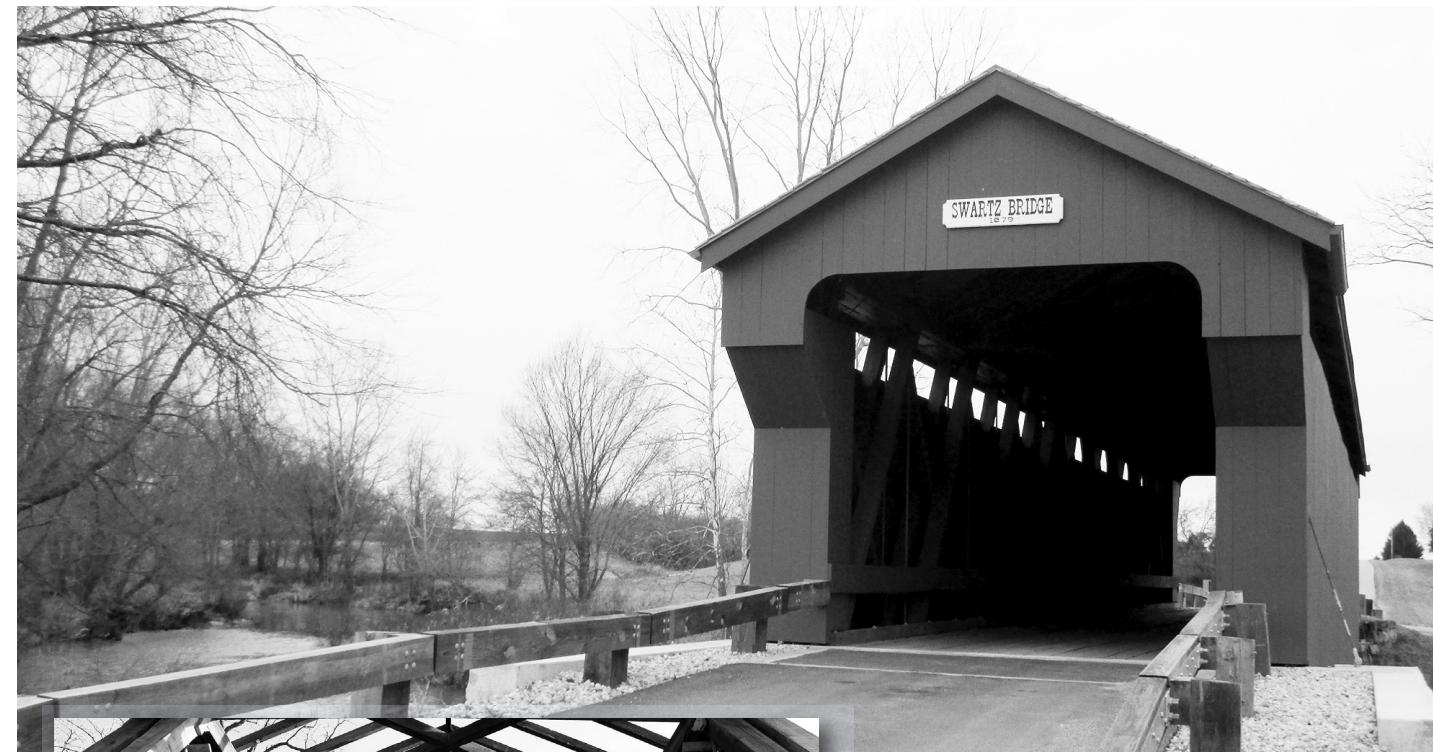
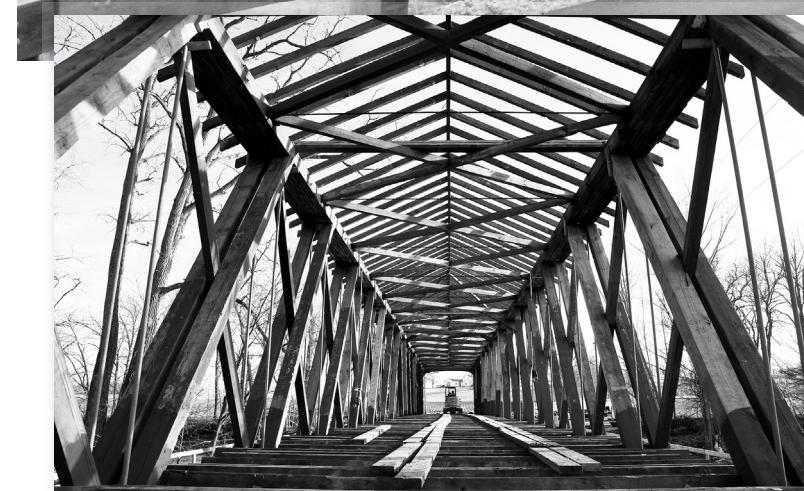
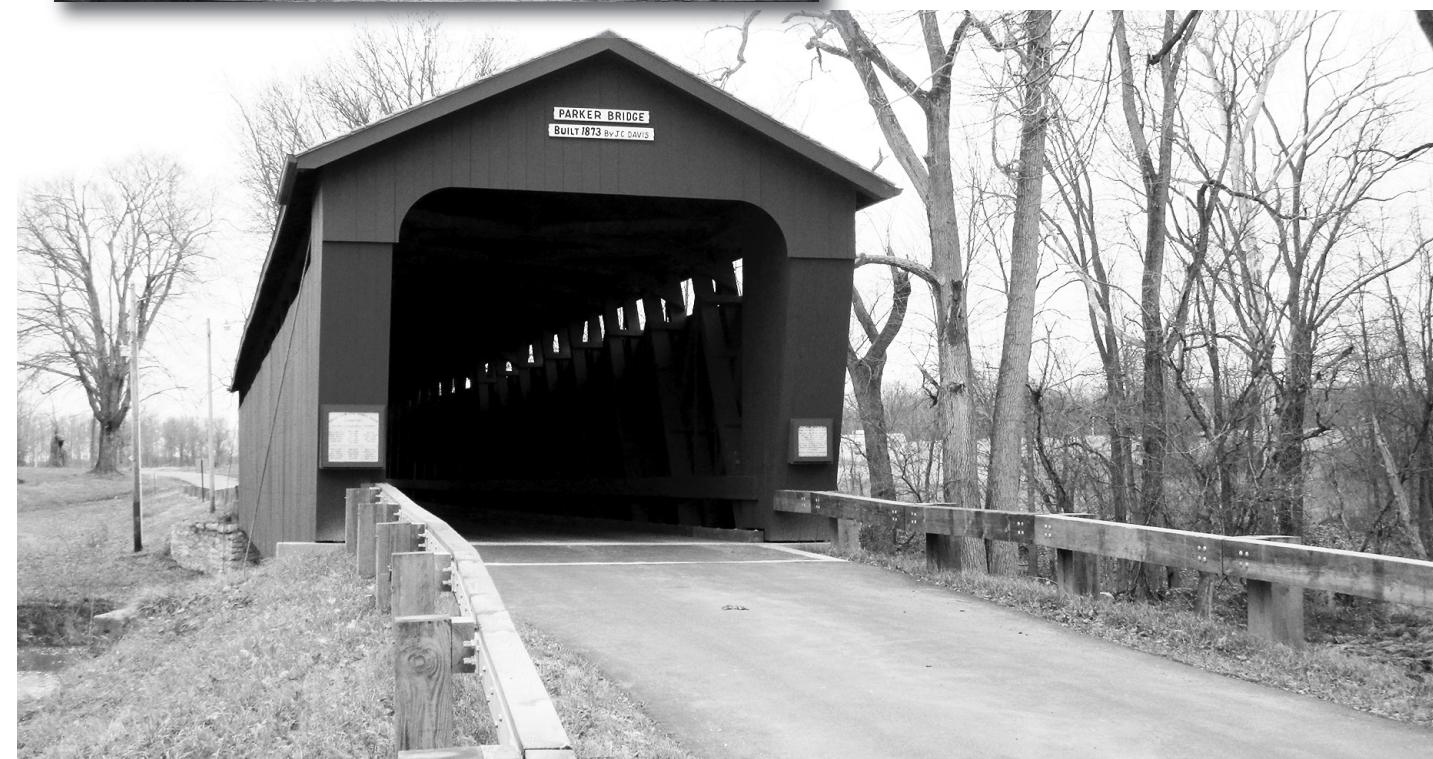
Restoration of Swartz and Parker covered bridges was officially completed the summer of 2018. The work, which addressed the bridges' framework to their siding, spanned about a year. Top and bottom photos by Angela Huston. Center photo by Mike Lang.

Both of the bridges had more excessive repairs than what had originally been determined and "a lot of the main support structure was completely replaced," said Wyandot County Engineer Mike Kohl.

The plan originally called for 15-20 percent of the bridges to be replaced, Kohl said. He estimated that over 50 percent of the Swartz bridge is new and the Parker bridge is "close to it."

In addition to new structural support, the bridges received all new floors, siding and roofs and "look like brand new bridges," said Kohl.

"We've made a lot of safety improvements," he added. The bridges have a better flooring system and the addition of strengthening and post-tensioning.
