# Regency “Swinging” Bridge

By James Taylor  
Goldthwaite Eagle

## HISTORY

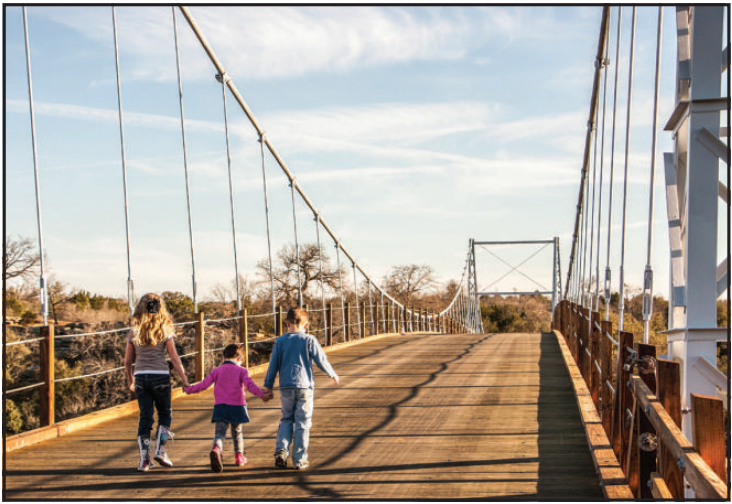
Regency “Swinging” Bridge, one of the last suspension bridges in service, is a favorite local attraction

The bridge consists of a 340-foot suspension span which is added to a 54-foot girder approach span at its north end. The foundations and piers are concrete, and the four towers consist of welded angle steel topped with cast-steel saddles to support the cables. The cables comprise 475 individual strands of no. 9 galvanized wire with a combined diameter of 3.25 inches. The 16-foot long roadway consists of wooden timbers supported on steel floor beams.
